## Veteran Tree Report The Green Leigh TN11 8QL

**Leigh Parish Council**

## 240517-1.0-LPC-IVTR-MS

June 2024

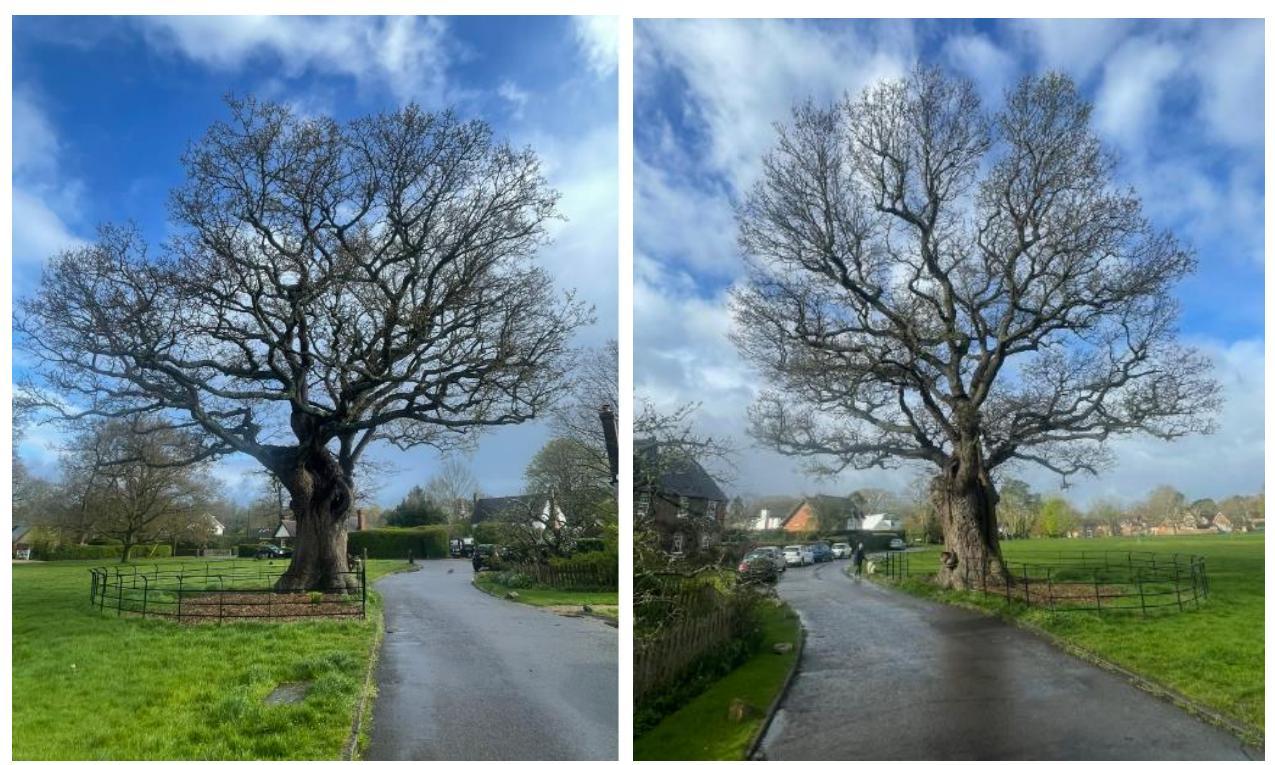
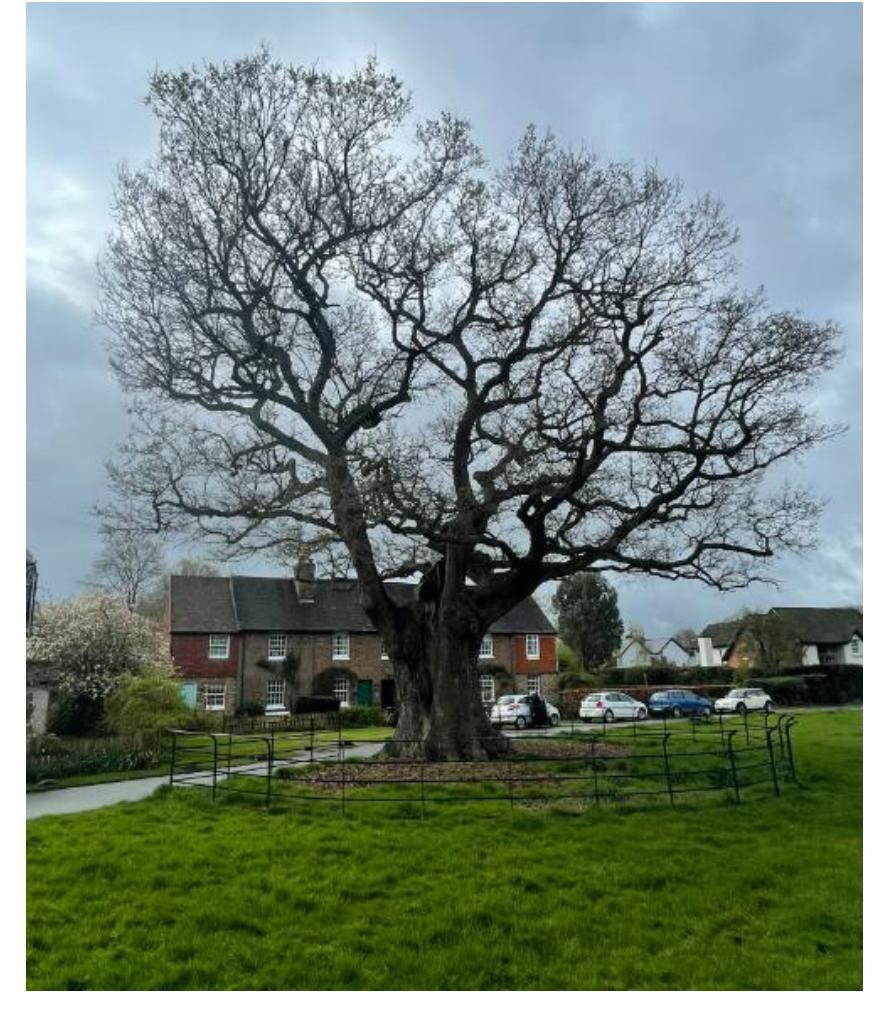
- **2.1.1** An historic English oak (*Quercus robur*) pollard with an approximately 2.5 m high bole, overall height of 14m and girth of 590cm. The bole has historically developed into three discrete, separate stems to the north (itself significantly hollow), north- west and the east, supported by a decayed, open cavity, shell of a trunk, the trunk consisting of at least two separate functional units divided by largely dysfunctional tissue and open cavity at ground level on the trees northern side.
- **2.1.2** For the purpose of the Stability Analysis, using TreeCalc, I will use the diameter of the entire trunk, rather than the two distinct sections.

Images 1, 2 and 3. Looking northeast, west and southwest.

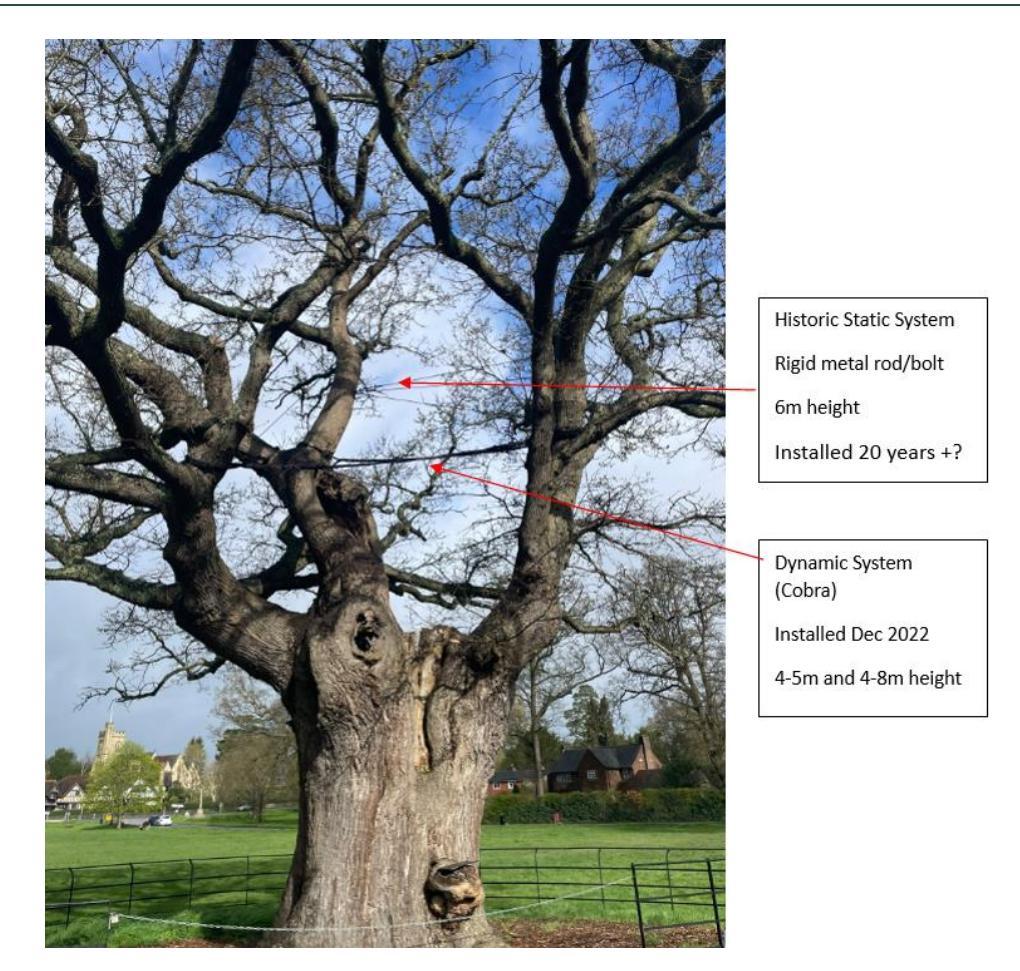
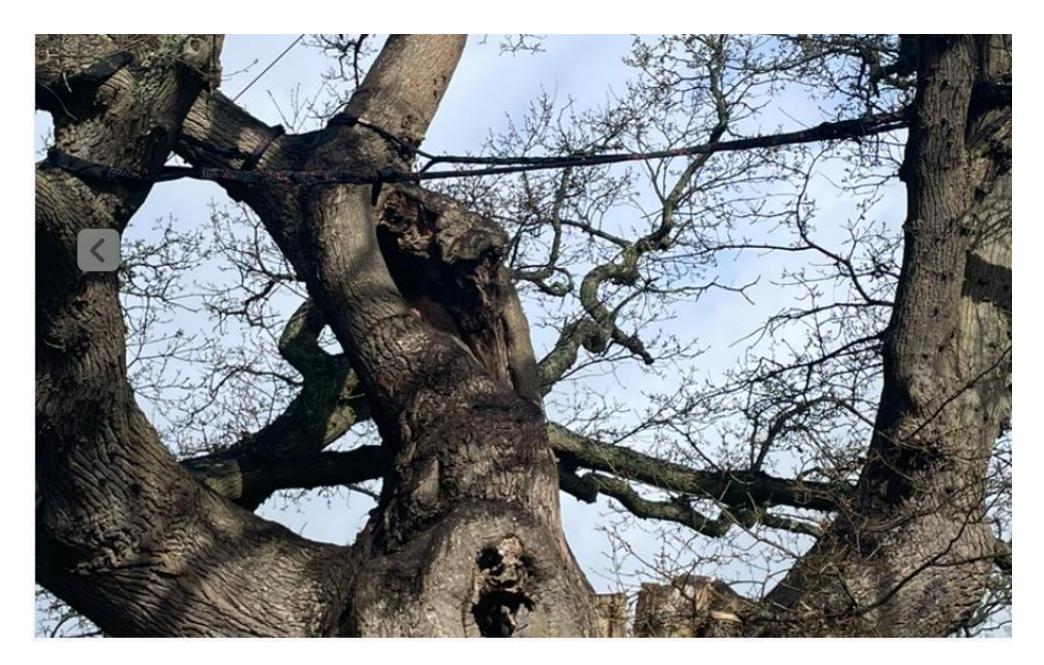
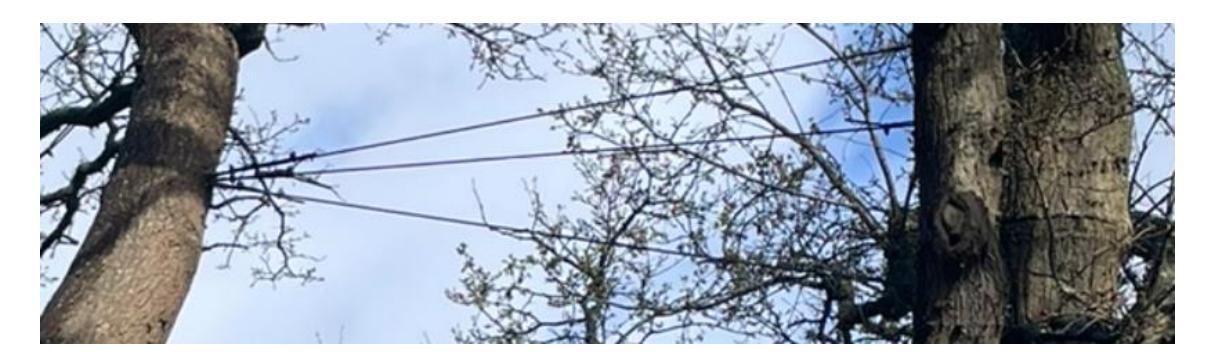
- **3.1.1** Historic static, rigid, metal rod and bolt cable bracing has been installed at an approximate height of 6m. The installation date is unknown.
- **3.1.2** Recent, dynamic, flexible, cable bracing (Cobra) has also been installed, at heights of between 4-5m and 4-8m. It is understood, it was installed in December 2022.
- **3.1.3** The positioning of both bracing systems are shown in images 5, 6 and 7 below.

Images 5, 6 (Dynamic system) and 7 (Static system).

**3.3.1** It is unclear what purpose the static system is offering. Given the time since it has been installed, to attempt to remove it is likely to result in damage. Removal could also alter the force distribution in the tree or (unintentionally) alleviate strain at specific points (e.g. forks), with a high level of unpredictability. As a result, It is recommended to leave this system in situ.

- **3.4.2** 'Cable bracing, propping and related techniques' states that 'dynamic systems should be installed only in the upper part of the crown; in the top half taken from the location of the defect'. It does also state that 'in more complicated cases, there is always the possibility to use a combination of cabling system at several levels'. Veteran trees fall within the category of 'more complicated cases' having complex morphology. However, this system has been installed much lower in the crown. It is not obviously apparent why it has been installed in this location.

- A crown reduction back to the previously pruned points
- The older, static bracing system to remain in situ.
- For the more recent dynamic (Cobra) bracing system, either:
  - The original installer provides a rationale of the positioning of the system and carries out a check, or.
  - An independent specialist carries out a review and reinstalls if necessary (we work with a third-party specialist, who we can recommend)
- Annual monitoring of the tree (to meet your duty of care)
- Reapplying woodchip mulch.
- Installing a board or other appropriate material to prevent entry via the cavity at ground level.

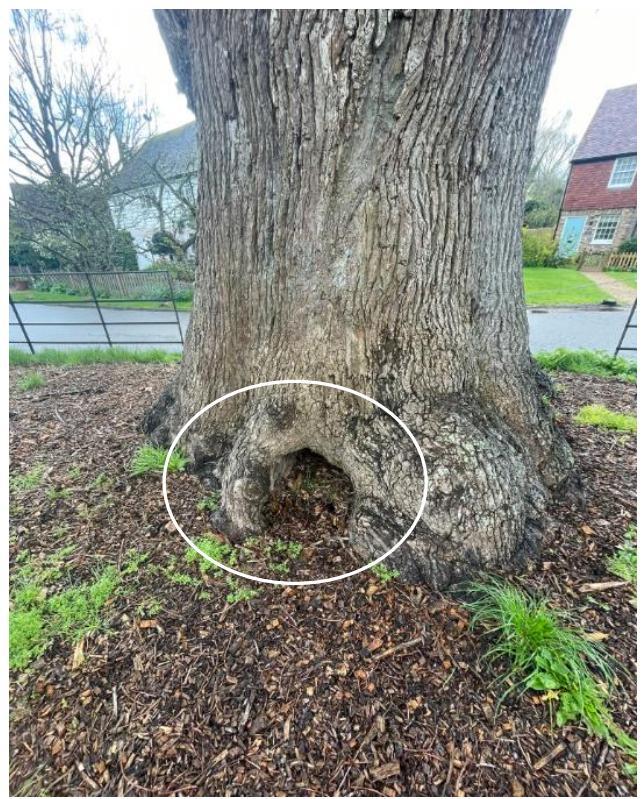
- **6.1.1** The tree is located on a relatively level area of grass, approximately 0.5m to the north of the road.
- **6.1.2** The road is understood to have a 30-mph speed limit. A count of passing cars at 11am on Thursday 4th April 2024, recorded 4 cars passing the tree within ten minutes (equating to approximately 24 cars per hour). Traffic generally appeared to be serving residents. It is likely that traffic is heavier during 'rush hours' and when cricket and other activities are present on the green. Traffic is free flowing. Cars are not parked beneath the tree.
- **6.1.3** The tree is fenced. A park bench is situated well outside of the canopy/the trees falling distance. It has been reported that children have climbed into the hollow tree through an open cavity at ground level (see image 11 below), although this seems unlikely at only 37cm in height.

Image 11: Cavity to the north.

Management	Positive	Negative	Effectiveness	Approximate	Action
Action	Considerations	Considerations	Over Time	Cost	date
Carefully install a board or other appropriate material to prevent entry into the tree via the cavity at ground level (see image 11).	Medium to Long- term solution, would prevent potential damage (including fire) inside the tree. Low cost	Ensure fixings are non- invasive, otherwise a risk of tree damage.	Medium to Long-term	unknown	Within 1 year.

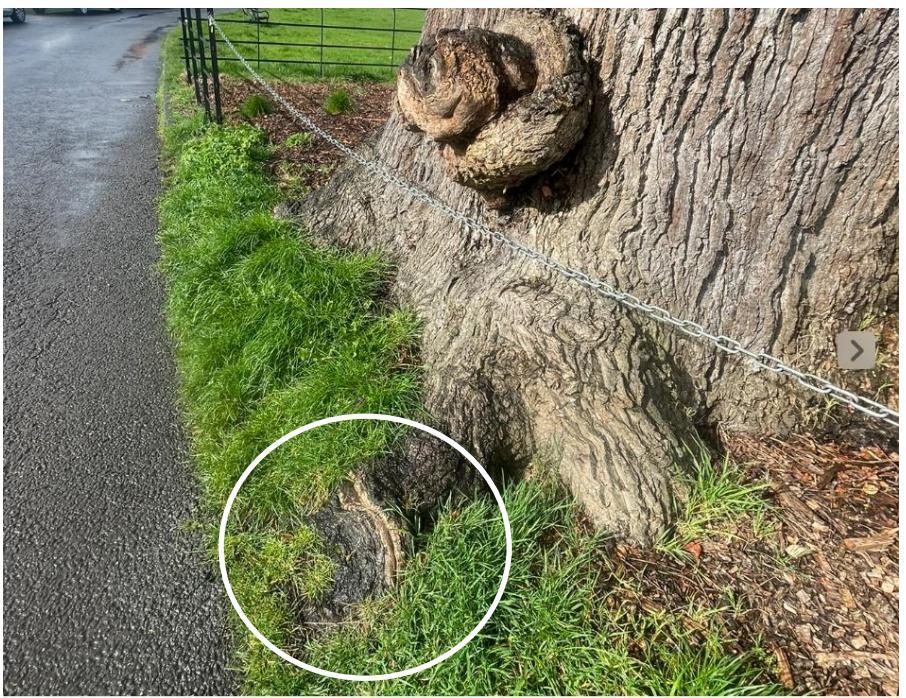
Treework Environmental Practice www.treeworks.co.uk **6.1.4** Historic damage/pruning of the buttress roots adjacent to the road on the trees southern aspect are evident.

Image 12: Historic root pruning

- **7.2** There were no observable indications of deteriorating root stability, such as the fruiting bodies of decay fungi or displaced soil. Historic root pruning and damage occurred, probably during the installation and/or resurfacing of the surfaced road to the south (see image 12 above).

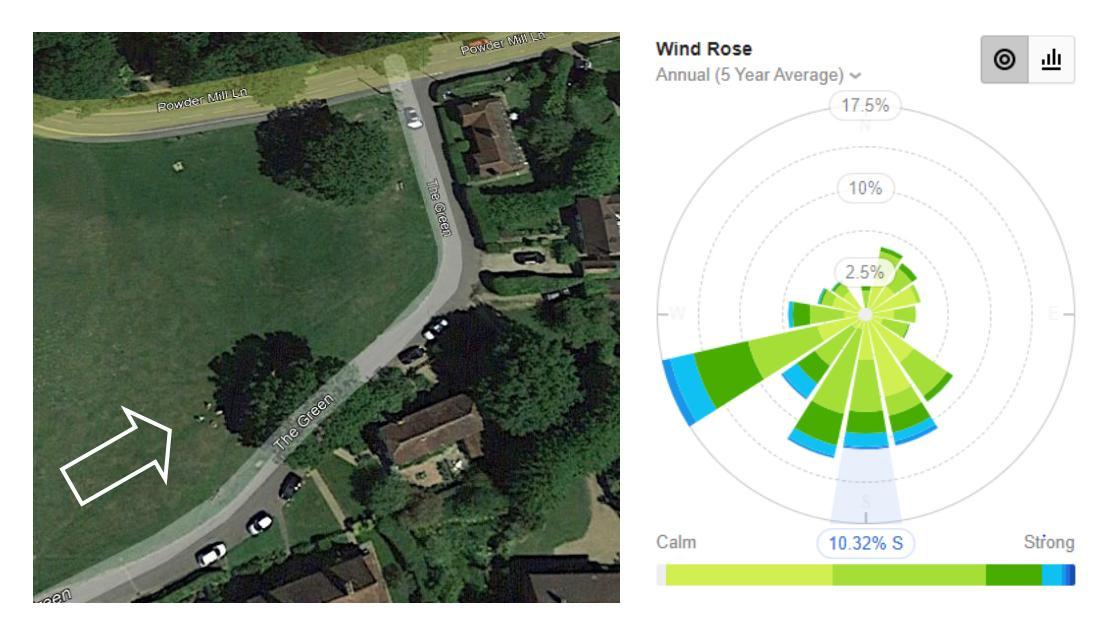
- **6.1.5** The tree stands alone, without shelter from neighbouring trees or vegetation.
- **6.1.6** Annual wind statistics for the Tonbridge area, from Willyweather.co.uk, based on a five year average, show that the dominant wind direction is west-southwest, while winds appear to also occur from southern directions (see Figures 13 and 14 below).

**Image 13**: Google aerial image with prevailing wind direction.

**Image 14**: Wind rose for Tonbridge area from willyweather.co.uk

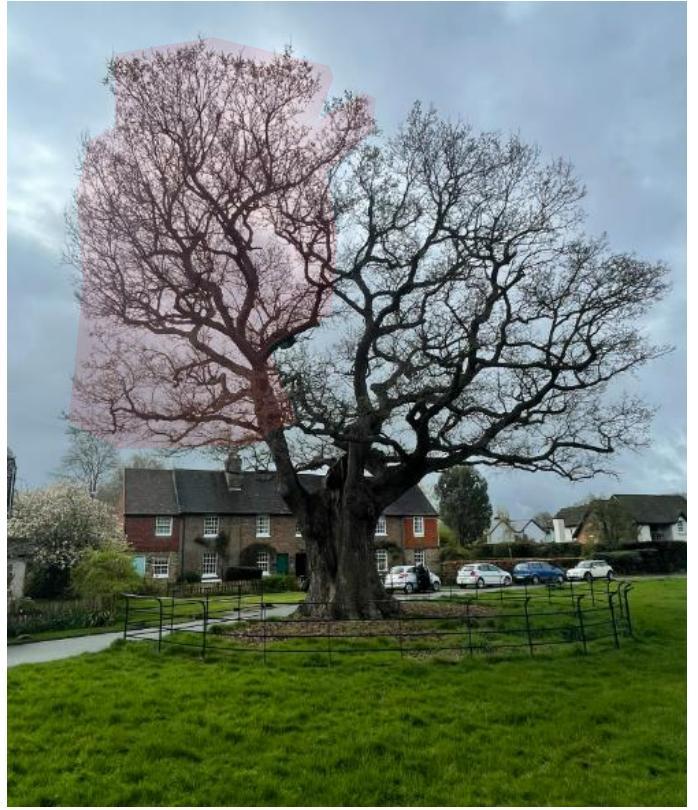
- **6.1.9** The crown that is supported on the western stems is slightly smaller than the crown on the eastern stem and so the upper half of the eastern crown, is a little more exposed, although not significantly (see image 15).

Image 15: Eastern canopy

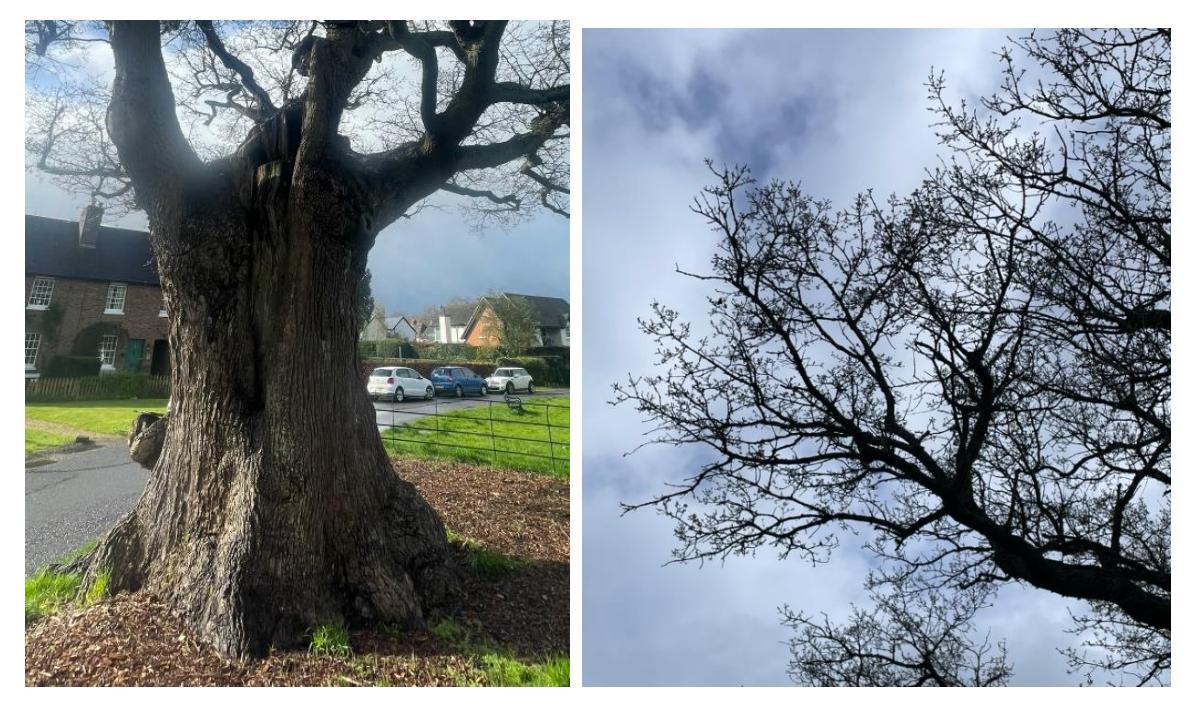
- **7.4** Despite the historic root damage, generally, the base and buttresses appear to have vigorous growth, including reaction wood and normal incremental stem growth (see image 16 below).

- **7.5** Each of the two sections of stem appear to be structurally sound with no significant current indications of structural instability.
- **7.6** Some upper crown die back was observed (see image 17 below), although not particularly unusual for a tree of this life stage. Such die back can be related to root decline/death. It should be monitored.

Image 16: Functional wood

Image 17: Tip die- back

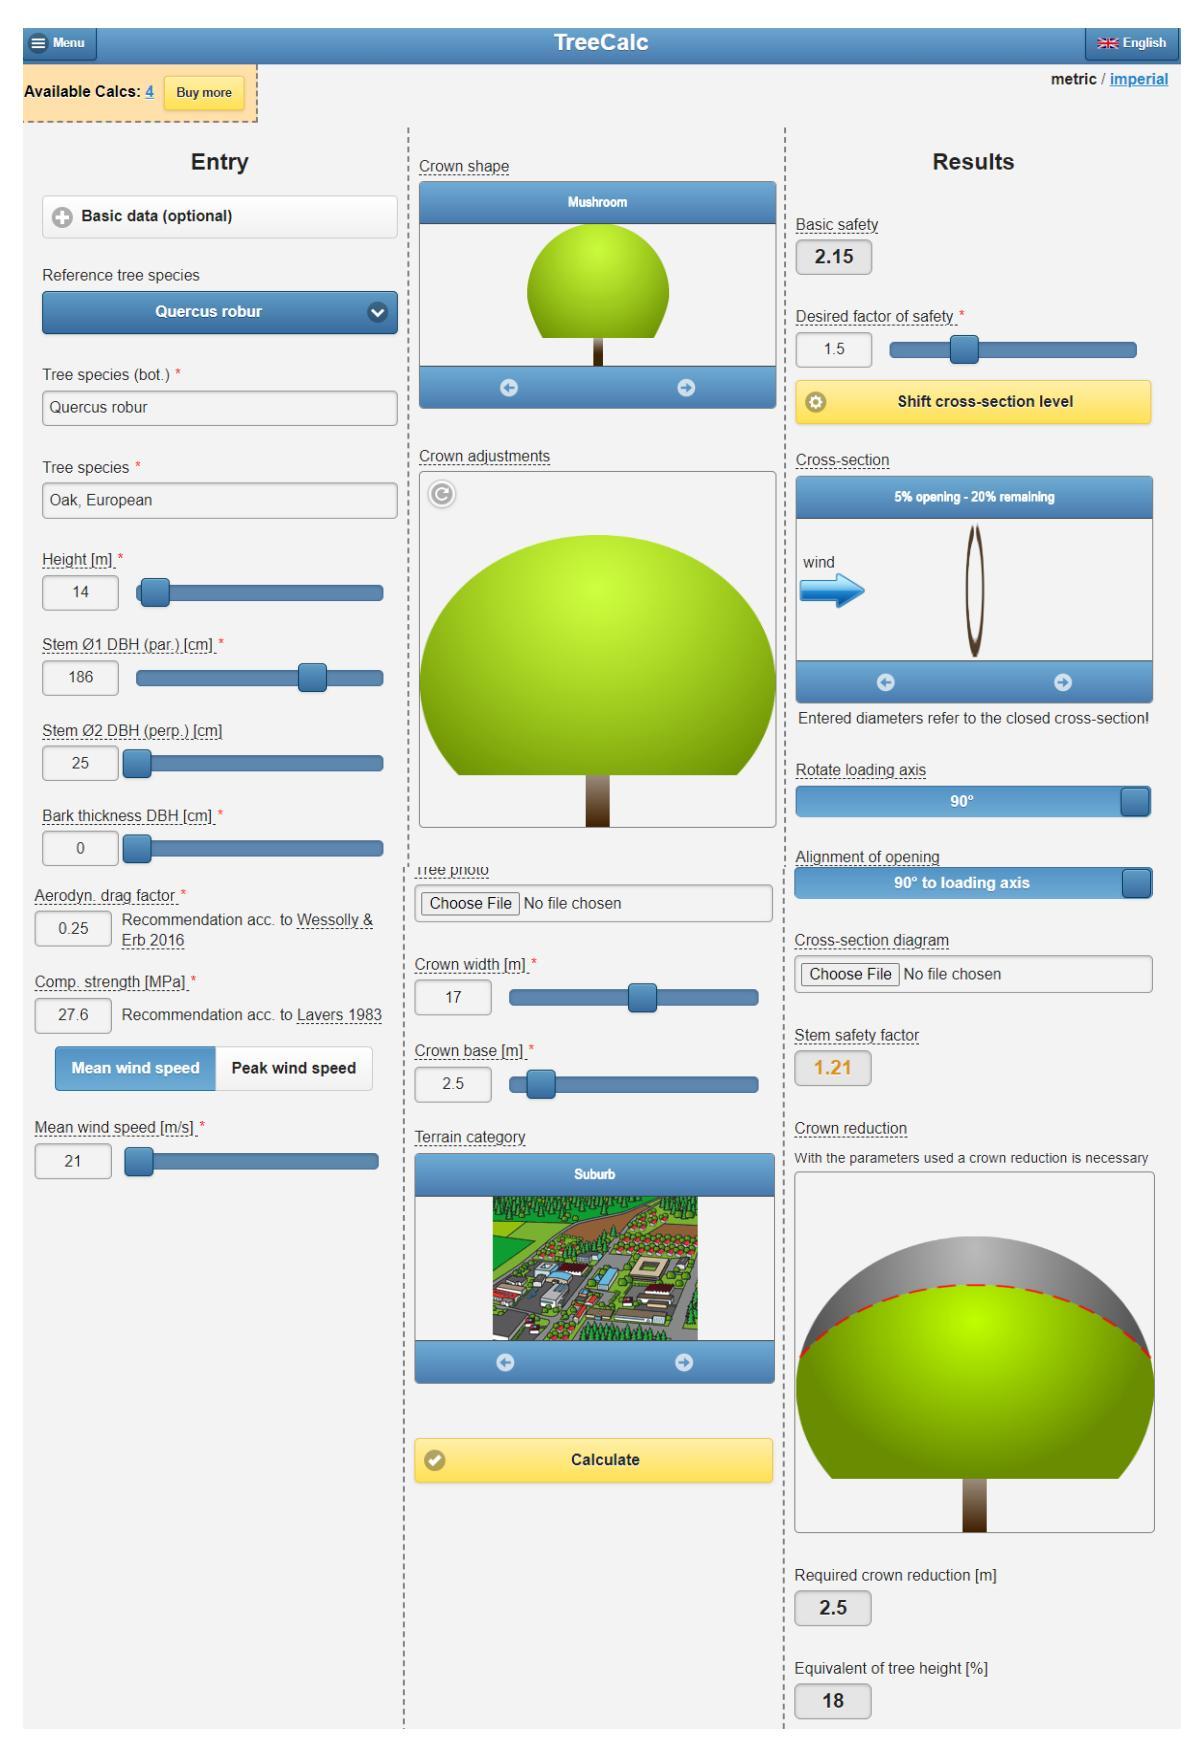
#### Image 18: TreeCalc Model

The TreeCalc model indicates that the Basic Safety Factor of the tree has been reduced by decay, as one would expect for a veteran tree at this life stage and habitat value. The model generates a Basic Safety Factor for the stem that is marginally below the nominal minimum Basic Safety Factor and as a result the model specifies a relatively minor crown reductions to increase the Basic Safety Factor to acceptable levels. The Quantified tree Risk Assessment calculation

- **9.5** To provide a degree of confidence that the subject tree poses a low risk of failure a Stem Safety Factor of greater than 1.5 is generally required.

Note that the recommendation of a cyclical crown reduction is considered sufficient to increase the Basic Safety Factor to acceptable levels irrespective of the bracing system.
