## Veteran Tree Report The Green Leigh TN11 8QL

**Leigh Parish Council**

## 240517-1.0-LPC-IVTR-MS

June 2024

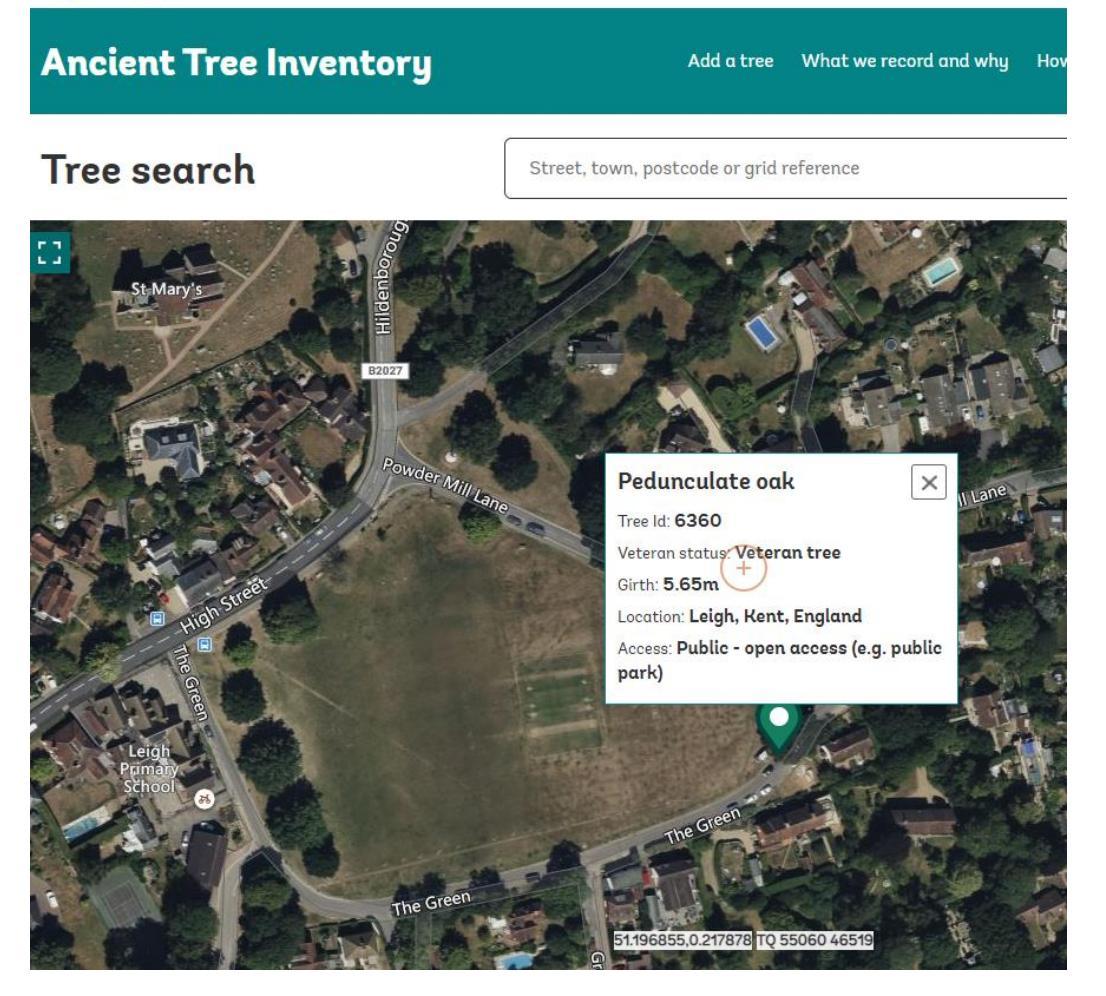
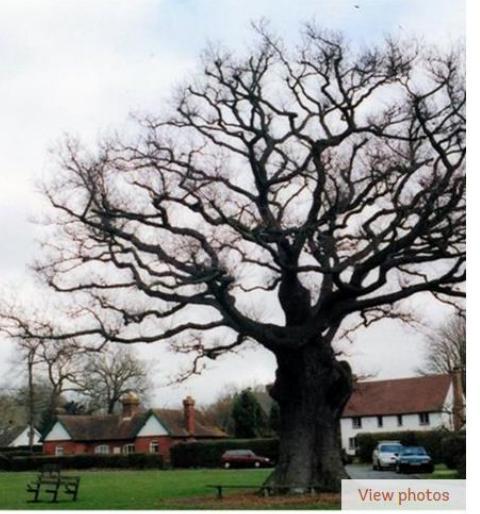
#### Image 8 & 9: ATI extract (Woodland Trust)

About the tree	Show more
Species:	Pedunculate oak Quercus robur
Form:	Pollard
Standing or fallen:	Standing
Living status:	Alive
Girth:	5.65m at a height of 1.50m
Veteran status:	Veteran tree
